Characteristics of the Heavy Rainfall Disaster in Central Taiwan, July 29 to 30, 2001.

ABSTRACT

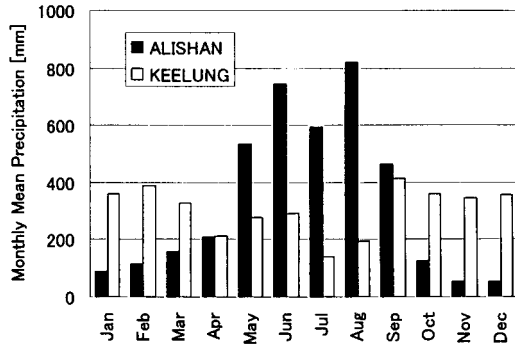
Fig. 5 Monthly mean precipitation at Alishan and Keelung, 1961 to 1990.

Normally, the western plain area of Taiwan receives little annual rainfall, whereas the north and central mountainous areas have high rainfall. (Fig.5, Taiwan Central Weather Bureau, 2001). In the central and southern areas, the rainy season is from May to September, and the difference in precipitation between the rainy and dry seasons is high (Figs. 4, 5).

Nanto Prefecture, which had heavy rain from typhoon No. 0108 is a high rainfall area in Taiwan; e.g., the highest normal monthly precipitation (September) at Alishan is 820 mm. Hualien Prefecture is a lower rainfall area than Nanto Prefecture, the normal highest monthly precipitation at Hualien City is 385 mm and

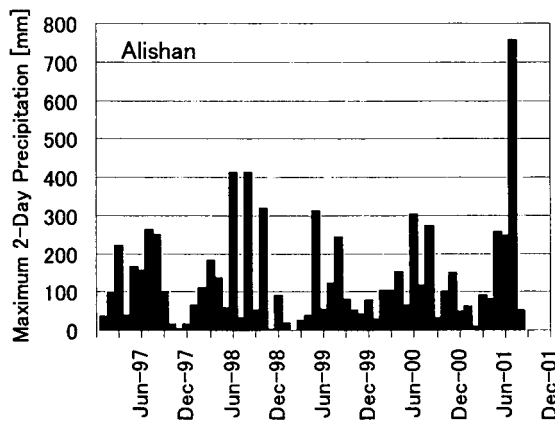
Fig. 6 Monthly highest 2-day precipitation at Alishan, Jan. 1997 through Aug. 2001.

The highest 2-day precipitation at Alishan per month from 1997 to 2001 is shown in Fig. 6. Each year there have been a few 300mm or more 2-day precipitations recorded, but no event comparable to the heavy rainfall of July 29-30 had occurred in the pre-

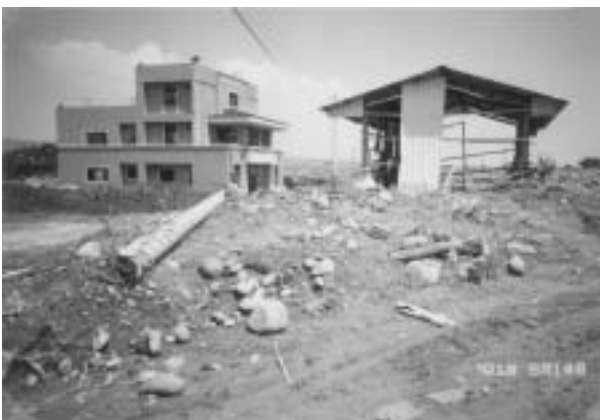
Photo 1: Flood damage at Mujiliao Village

In the upstream area of the Tungpurei River, rainfall intensity increased from dawn 30 July, and the highest river water stage occurred at about 8:30 on 30 July near the bank breach location. According to residents of the village, at about 7:30, those who had been informed of the high river water stage started to evacuate the village. As houses were destroyed by the flood flow just after 8:30, the lives of some of the residents may have been saved by that evacuation. Many large boulders with a maximum diameter of more than 1m were deposited along the trace of the flood flow. The flood flow carried a great deal of sediment. Moreover, the pass that the water flowed down was very narrow, indication that the flow occurred at high speed without stoppage or diffusion. In the stricken village, there was very little distance between completely destroyed houses and those that remained intact.

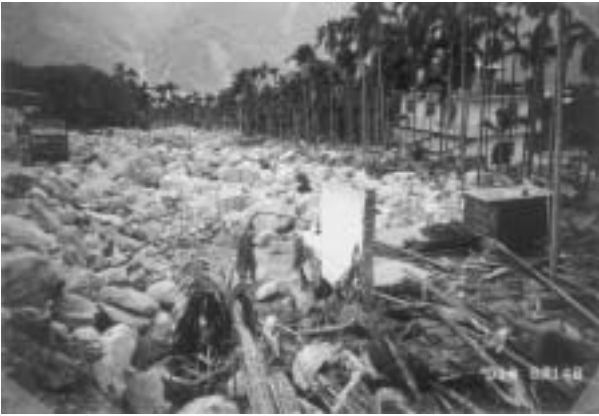
Along the national road from Shuili to Hsini, some villages located on steep slope areas had been destroyed by debris flows. Heavy damage caused by debris and sediment flows in particular occurred at Chunkeng in Shuili County, at Hsinhsiang in Hsini County and elsewhere. Photo 2 shows Chunkeng Village after the debris flow. This photo clearly indicates the severity of the debris flow by the trace it left. In this village, the first floor of the social activities center was demolished by huge boulders. The building which, if in Japan, would be used as a refuge shelter was badly damaged by the debris flow. Further upstream, the scale of the debris and sediment flows damage was even greater, and huge boulders and large deposits of sediment could be seen in many places in Hsini County. Moreover, many roads and bridges also were damaged.

Photo 2 Result of the sediment disaster at Chunkeng Village

previously this area had frequently experienced heavy rainfall; heavy rainfall greater than that of 2001 event had been recorded five years before, but no severe sediment damage was reported at that time. Due to the heavy rainfall, the great volume of unstable sediment left by the Chichi earthquake of September 1999 in the mountainous area, may have moved and flowed down abruptly.

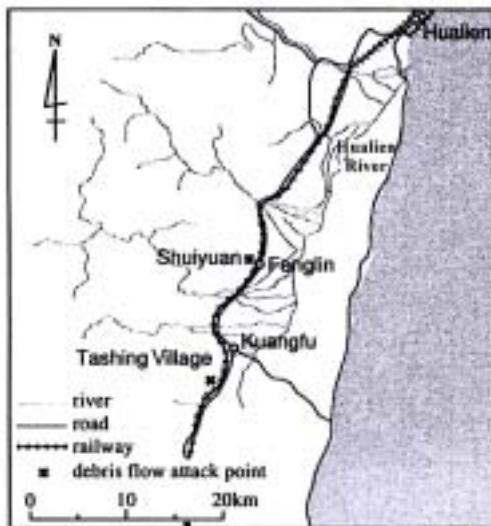
Fig.9 Locations surveyed in Hualien Prefecture

Hualien Prefecture was hit by heavy rainfall during the evening of 29 July, and debris flows occurred at eight locations early in the morning of 30 July. Tashing Village in Kuangfu County and Shuiyuan in Fenglin suffered particularly heavy damage (Fig.9). Though Hualien Prefecture is famous for the production of marble, but the disasters occurred in a geological andesite zone.

A debris flow also took place at Shuiyuan in Fenglin. The total volume of sediment yield was estimated to be about 70 thousand m³. Three houses were buried, one of which housed seven persons, five of whom were killed and one missing. The number of houses inundated was about 100.

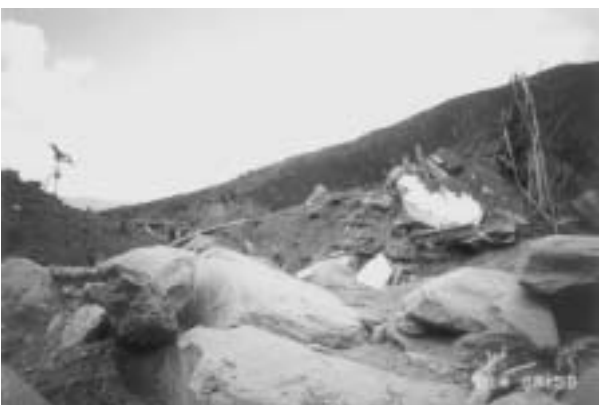
Photo 3 Debris left by the sediment disaster at Tashing Village

At Tashing Village, the large scaled debris flow was caused by slope failure. An enormous volume of gravel and sediment yield flowed down, some of which overflowed the bank and struck houses and fields. Photo 3 shows part of destruction at Tashing Village. Forty-one persons died or were missing. About 200 houses were damaged, 16 of which were completely destroyed, and about 50 hectares of fields were buried under sediment. Maximum sediment accumulation thickness was 15m, and the total volume of sediment moved was estimated to be about 1.5 million m³. Public officials of the Hualien prefectural government said that when removal of the sediment and driftwood was finished, they planned to make residents affected by the debris flow move to a new location.
