Instrumented Model Slope Failure due to Water Seepage

Rolando P. ORENSE¹, Suguru SHIMOMA²,
Kengo MAEDA³ and Ikuo TOWHATA³

³Department of Civil Engineering, University of Tokyo, Japan

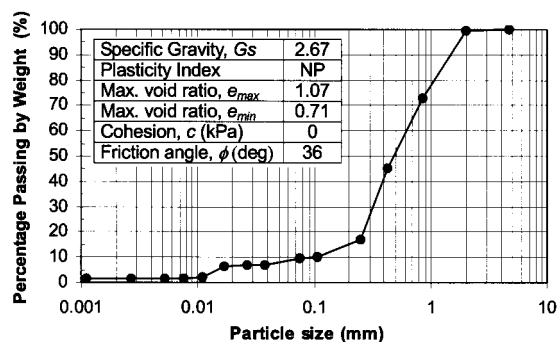
Fig. 2 Grain size distribution curve and physical properties of the soil used

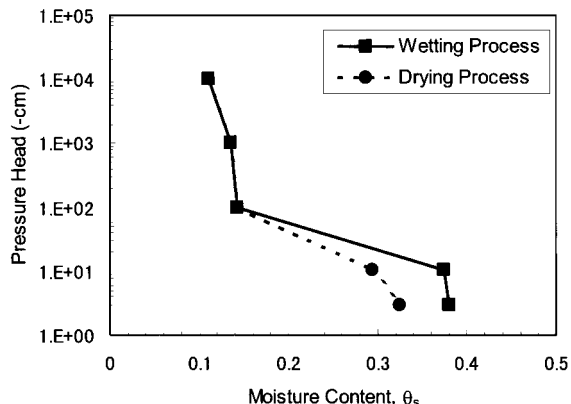
Fig. 3 Soil water characteristic curves for Omigawa soil

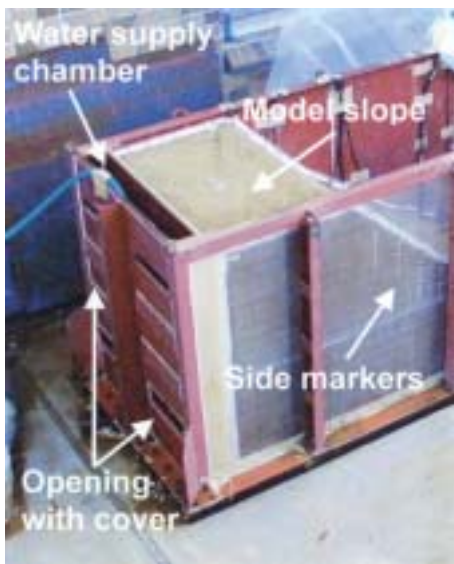
Fig. 5 Photo of the experimental soil box

The tank used in the model tests is shown schematically in Fig. 4. It is 220cm long, 80cm wide and 100cm high. Its walls are made of steel plates, except for the front one which is made of acrylic glass for easy observation of the deformation process. The box is divided into three sections; a central portion 197cm long that is used to construct the slope and left and right chambers, each 11.5cm wide, respectively used to supply and drain the water. Perforated steel walls covered with wire mesh divide these three sections to allow the easy movement of water through them without washing out the soil grains. The left outer wall of the box adjacent to the water supply chamber has small rectangular openings with covers that are positioned at appropriate locations (see Fig. 5).

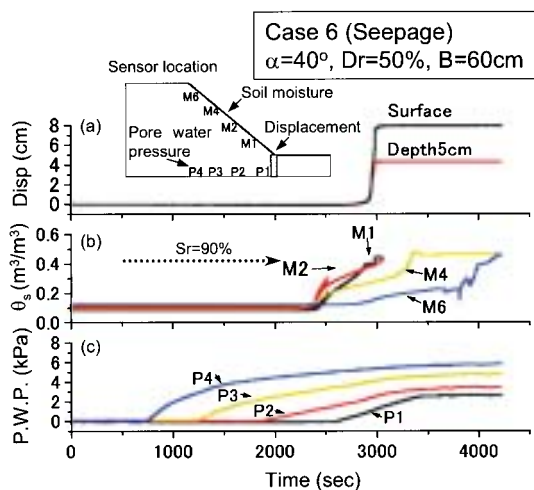
Fig. 10 Time histories of: (a) toe displacement; (b) volumetric water content, θ_s ; (c) pore-water pressure (P.W.P.) for Case 6

Fig. 10 shows the time histories of monitored sub-surface deformation near the toe of the slope, volumetric moisture content, θ_s , and pore water pressure (P.W.P.) at the sensor locations (also depicted in the figure). Soil moisture sensors were installed at $d=5\text{cm}$ from the surface of the slope. The progress of the wetting front within the model ground is clear in Fig. 10(c), in which the increase in pore-water pressure recorded starting from P4 to P1 indicates gradual formation of the water table from left to right, analogous to the direction of seepage flow.

About 2400 sec after the test began, the wetting front reached the locations of the soil moisture sensors, and a rapid increase in moisture content was recorded near the toe of the slope (M1 and M2). After some time had passed, minute slope movement occurred, as evidenced by the displacement time history in Fig. 10(a). When the volumetric water content in this region reached $\theta_s=0.42$, equivalent to the degree of saturation $S_r=90\%$, large deformation was triggered near the toe. This deformation was extremely rapid, reaching a maximum surface displacement of 8cm within a few seconds (Fig. 10(a)). In contrast, maximum deformation of 4cm was monitored 5cm below the surface, indicating that only the surficial portion of the downslope was involved in the sliding process. These findings are consistent with those obtained with the video cameras which showed that in the upslope section, a portion about 15-20cm thick slid down the slope (Fig. 11). It should be stated that during the deformation process, soil moisture sensors M1 and M2 were displaced by the moving ground, causing erratic readings. Sensor readings therefore were terminated at that time (see Fig. 10(b)).

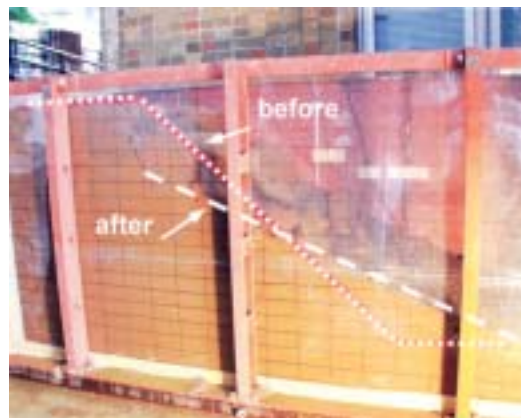
Fig. 11 Photo showing the model slope after the test (Case 6)

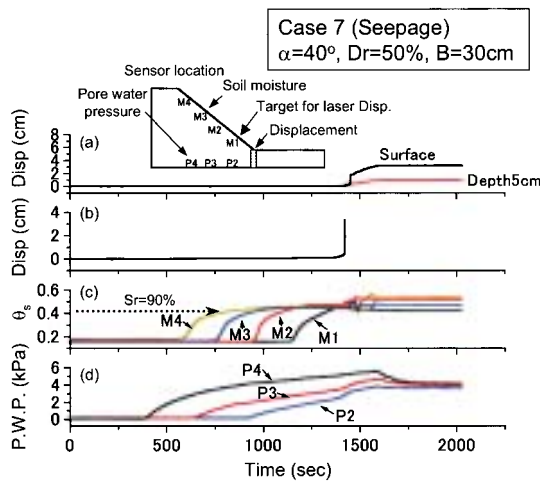
Fig. 12 Time histories of: (a) toe displacement by the shear displacement transducer; (b) target displacement by the laser displacement sensor; (c) volumetric water content, θ_s ; (d) pore-water pressure (P.W.P.) for Case 7

The time histories recorded by the sensors as well as the sensor locations are shown in Fig. 12. As in Case 6, the advance of the wetting front is evident from the time history of the pore-water pressure (Fig. 12(d)), but unlike that case, the wetting front reached the topmost soil moisture sensor (M4) first, and saturation started near the top of slope and moved toward the bottom (Fig. 12(c)). Initially, the rise in the volumetric water content was rapid then became gradual as the ground approached full saturation. When the volumetric water content at M1 reached $\theta_s=0.42$ (about $S_r=90\%$), deformation with maximum surface displacement of about 3cm was triggered at the toe. Again, only the surficial portion of the slope was involved in the flow. Movement of the target placed near the toe of slope, obtained by the laser displacement

It is interesting that deformation of the ground did not start even when the upper (M4) and middle (M3, M2) portions of the slope were almost saturated ($S_r>90\%$). In fact, deformation of the slope began only when there was almost full-saturation near the toe of the slope. This means that saturation at any point within a slope will not result in slope failure; rather, movement is initiated only when the most critical region, in this case the toe of the slope, becomes saturated. Nevertheless, the high degree of saturation over the whole slope contributed to the rapid propagation of failure. Fig. 13 shows the deformed configuration of the slope after the test. Although movement affected almost the entire slope, failure generally involved only the superficial portion of the slope.

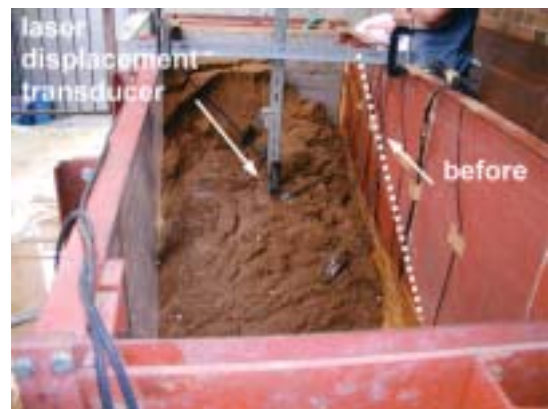
Fig. 13 Photo showing the model slope after the test (Case 7)

In Case 7, the start of mass movement was registered about 23 minutes after the start of water infiltration. Collapse began near the bottom half of the slope adjacent to the steel wall and propagated upward to the other parts of the slope. Compared with the failure in Case 6, the video images taken by the cameras showed more rapid progression of movement and failure involving almost the entire slope occurred in less than a minute. This was because the entire slope was in almost fully saturated state and therefore had lower strength. As in Case 6, non-circular retrogressive failure surfaces were present.

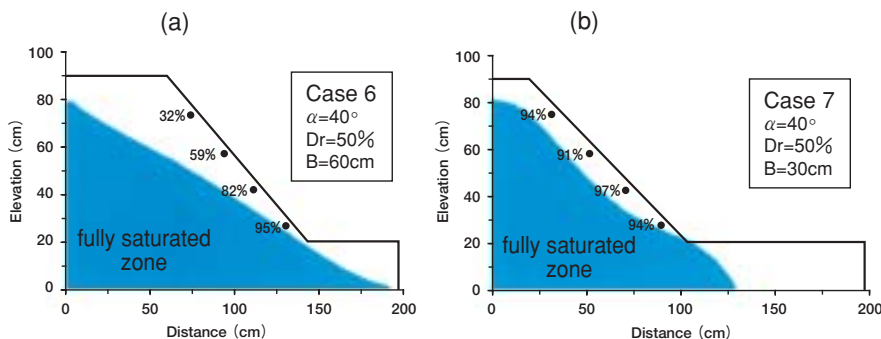
Fig. 14 Distributions of saturated zone at the time of failure: (a) Case 6; (b) Case 7 (seepage tests)

To understand the role of the saturated zone in slope deformation, pore-water pressure heads within the slope (monitored by pore pressure meters installed at the bottom of the box) were calculated and plotted. Distributions of the saturated zone for the slopes in Cases 6 and 7 at the time of slope failure are shown in Fig. 14.

The shaded portions correspond to fully saturated regions within the model ground whose upper boundaries correspond to piezometric levels. Numbers adjacent to the slope (expressed in percent) represent the S_r as monitored by the soil moisture sensors (shown by black dots) located 5cm below the slope surface. For Case 7, the water table is almost parallel to the slope, inducing a high moisture content over the entire slope. In comparison, the upper portion of the slope in Case 6 is far from the phreatic surface; therefore lower soil moisture contents were recorded at this location.

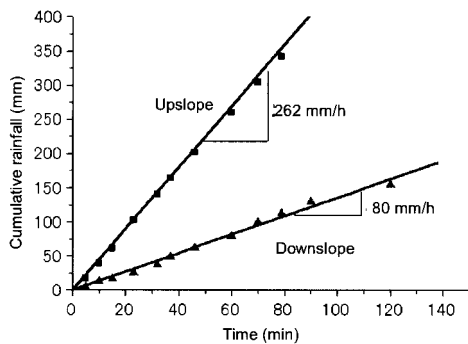
Fig. 15 Accumulated rainfall vs. time upslope and downslope in the model ground (Case 8)

A slope with the Model B type of configuration was used in Case 8. The thickness of the deposit was set at $h=20\text{cm}$. Artificial rain was sprinkled on top of the slope through a hose positioned outside the box, with its nozzle directed over the entire exposed slope surface. The actual rainfall intensity, r , was obtained by monitoring the rainwater that accumulated at rainfall gauges positioned at the top and at the bottom of the slope. Fig. 15 shows variation in cumulative rainfall over time at these two locations. The plots of the data points have almost constant slopes during the duration of the experiment, evidence of constant intensity at each

location. The upslope registered greater intensity ($r=262\text{ mm/h}$) than the downslope ($r=80\text{ mm/h}$), however, because it was nearer the source of rainfall.

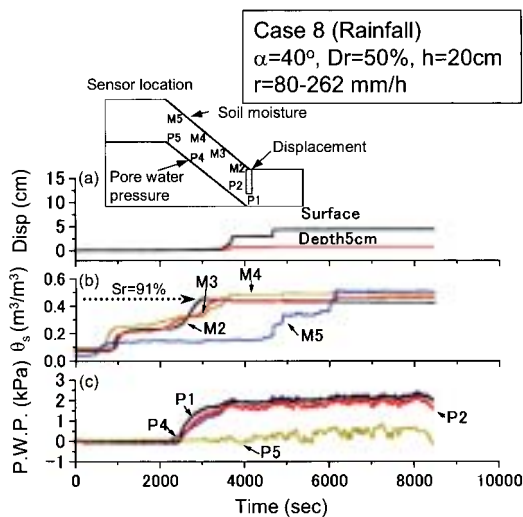
Fig. 16 Time histories of: (a) toe displacement; (b) volumetric water content, θ_s ; (c) pore-water pressure (P.W.P.) for Case 8

Fig. 16 gives the time histories of ground displacement, soil moisture contents, and pore-water pressures monitored from the onset of rainfall. Fig. 16(b) shows that when infiltrating rainwater reached the sensor locations (at $t=800\text{-}900\text{ sec}$), soil moisture contents at all locations increased simultaneously. Upon reaching values of about $\theta_s=0.22\text{-}0.25$, they remained constant as the wetting front progressed downward toward the impermeable base. Upon reaching that base, water accumulated and a water table formed ($t=2200\text{ sec}$), specifically in the lower half of the slope, as shown by the increase in pore water pressure (P1, P2, P4) in Fig. 16(c). The water table continued to rise upward and on reaching the soil moisture sensor locations, the soil moisture content (at sensors M2, M3, M4) increased again. Note that the pore-water pressure at the P5 location near the top of the slope did not increase, possibly because rainwater did not accumulate there but flowed down the slope. Consequently, sensor M5 did not register much of an increase in soil moisture during the initial phase of the test.

At $t=1800\text{ sec}$, a crack began to appear near the top of the slope (Fig. 17(a)). At $t=3500\text{ sec}$, when the soil moisture sensor near the toe (M2) registered $\theta_s=0.43$ (corresponding to $S_r=91\%$), the slope slowly began to move but stopped 200 sec later. When the volumetric water content near the top (M5) began to increase however, probably as a result of water infiltrating through the crack formed adjacent to the sensor, the entire slope suddenly began to move as a whole. Unfortunately, this movement was not captured by the shear displacement sensor installed at the slope

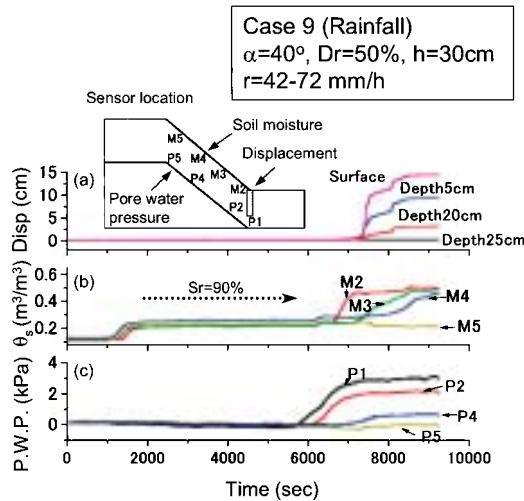
Fig. 19 Time histories of: (a) toe displacement; (b) volumetric water content, θ_s ; (c) pore-water pressure (P.W.P.) for Case 9

The recorded time histories are shown in Fig. 19. As in Case 8, the rise in volumetric water content was a two-step process.

After reaching a value of $\theta_s=0.22\text{-}0.25$, all the soil moisture content readings remained constant, indicative that the rate of infiltration within the model ground was relatively constant. A water table began to develop near the toe of the slope at $t=6000\text{ sec}$, corresponding to the time the wetting front reached the base. Note that the time required to develop this water table was longer than in Case 8 because of the lower rainfall intensity and thicker depth through which rainwater needed to percolate to reach the base. The water table formed only near the bottom portion of the base (P1, P2). Rainwater at the top of the slope probably flowed downward, preventing an accumulation of water in the top portion. As the water table near the toe rose, the wetting front also moved upward, causing an increase in the volumetric water content near the surface soil at the slope toe (M2).

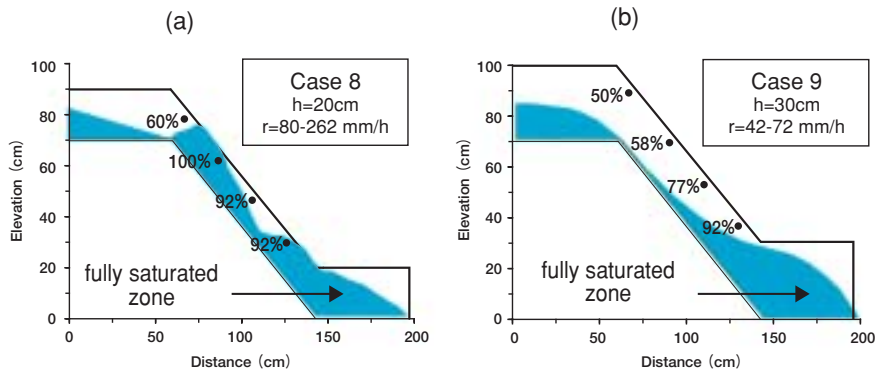
Fig. 21 Distributions of saturated zone at the time of failure: (a) Case 8; (b) Case 9 (rainfall tests)

Distributions of the saturated region and moisture content at the time of failure for Cases 8 and 9 are shown in Fig. 21. As in the earlier cases, the shaded portions correspond to fully saturated regions within the model ground as calculated from the pore water

pressure readings, whereas the numbers (in percent) are the degrees of saturation as registered by the moisture sensors whose locations are shown by black dots. In Case 8, the rainfall intensity was very high ($r=262$ mm/h), therefore the infiltration rate was very fast and a water table was able to form along the sloping boundary of the impervious base, inducing higher moisture contents in the surficial soil. Moreover, the 20cm thickness of the model slope allowed easy saturation of the ground. In contrast, the rainfall intensity in Case 9 was much lower ($r=72$ mm/h), and the thickness of the deposit was greater ($h=30$ cm). As a result, rain-water did not accumulate along the slope. Instead it flowed downward. Consequently, only the lower portion of the slope was near full saturation at the onset of failure.

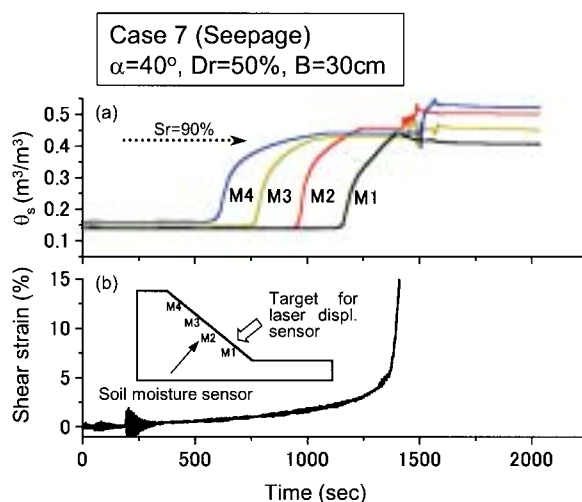
Fig. 22 Time histories of: (a) volumetric water content, θ_s ; (b) shear strain near the toe calculated from laser displacement sensor readings in Case 7

To expound on this, the results for Case 7 are presented, in which the motion of a target installed on the slope surface was observed with a laser displacement transducer. The target's location is shown by the arrow in Fig. 12, and the laser displacement transducer is positioned upslope of the target (Fig. 6b). Surface displacement readings obtained by the laser sensor (Fig. 12(b)) are converted to the equivalent shear strain by considering a 2cm thick surface soil undergoing uniform straining. The calculated shear strain time history as well as the soil moisture contents are presented in detail in Fig. 22. The figure shows that when the volumetric water content in the upper portions of the slope (M4 and M3) located far enough from the target began to increase ($t=600$ sec), minor deformation started at the bottom of the slope. Such movement may be associated with downward seepage forces as the wetting front moves from the top to bottom portion of the slope. Slope deformation continued to increase as water continued to seep in. When the soil moisture content in M1 location reached the threshold value ($t=1300$ sec), failure was triggered.
