Destruction mechanism of Oklahoma Tornadoes in 1999

ABSTRACT

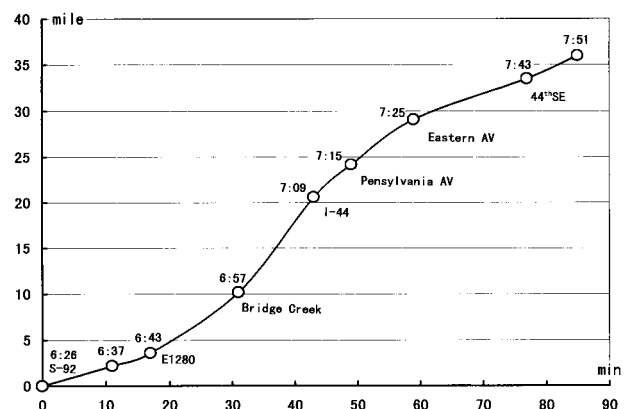
Fig. 2 Run-time diagram of fiercest tornado

After crossing E1280th Road east of Amber, the speed of the tornado increased, became almost 50 mph and attacked the mobile home community in Bridge Creek at around 6:57 p.m. Fig.2, a run-time curve of the main tornado after crossing US92 south of Amber, clearly shows the acceleration. When stretched, a vortex tends to stick to the ground more strongly. The radius of revolution becomes shorter, the atmospheric pressure at the center drops, and the revolving speed increases to gain centrifugal force to balance with the low pressure. An aerial photograph taken the following day shows the bare ground from which grass was torn off. This phenomenon is not yet clarified, but we can imagine that the same thing may happen when we vacuum grass with a powerful vacuum cleaner, which reminds us of Fujita's (1971) suction vortex. All that we could see there on July 2 was the wreckage of a small factory and what seemed to have been trailer houses scattered far away, and it was unbelievable that 235 houses were destroyed and 11 people died. The important point is that the helicopter pilots of CH4 and CH9, consistently following the main tornado, could not catch the scene of the devastation. Though it was quite natural that they could not go close to the dangerous tornado, they must have been south-southeast of the tornado across I-44 at that moment. Therefore it may be inferred that a tornado cannot be seen in case of heavy touch down. What we can see of a funnel cloud is only the part where water vapor becomes drops by the decrease of atmospheric pressure at the center of the tornado.

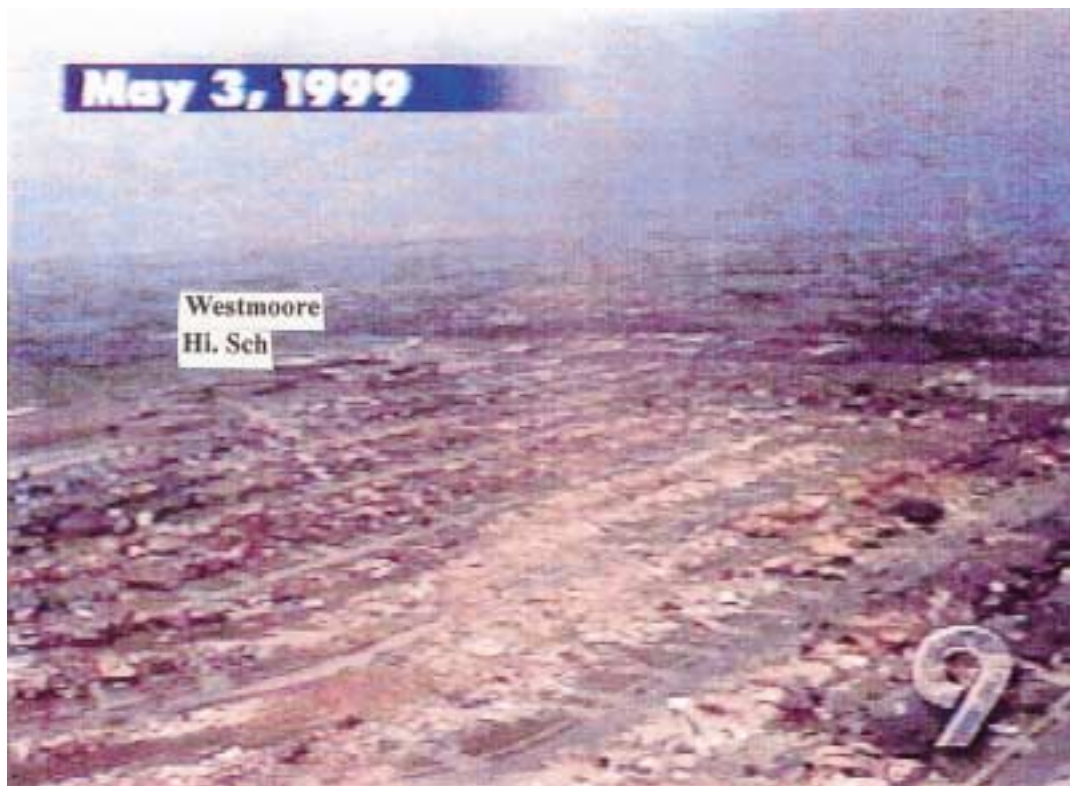
Photo. 2 Disaster of Eastlake Residential Area, seen also in Photo. 1, (from broadcast by KWTU)

When the tornado was still around I-35, CH9's helicopter arrived above the Eastlake residential area and took a close-up picture of the destruction (Photo.2). The picture shows almost no projecting things within about 50 yards at the center of 100-yards-wide area. If this is the radius of the vortex core, it is smaller than half a mile vortex in diameter, which will be considered later.

If a lot of such child vortexes are around the parent vortex, the child vortex density becomes thicker in the right side of the proceeding direction where the friction is stronger, and thinner in the left side. Also, the child vortexes usually adhere behind the protuberances on the ground and sustain the frictional force of the rotational motion of the parent vortex. When these vortexes cling around the parent vortex and stretched by the parent vortex flow, the angular momentum of the child vortexes is conserved, speeding up the rotation and lowering the pressure at the child vortex's center. The flow falls from the rear to the right side to compensate the momentum consumed by friction, and the flow rises from the right to the front side. A child vortex often sucks up, conveys everything and releases it when the friction decays. This idea can be applied to the cases in Bridge Creek and Eastlake residential area (Photo.2), and describes the damage in Del City and Midwest City, which is mentioned later.

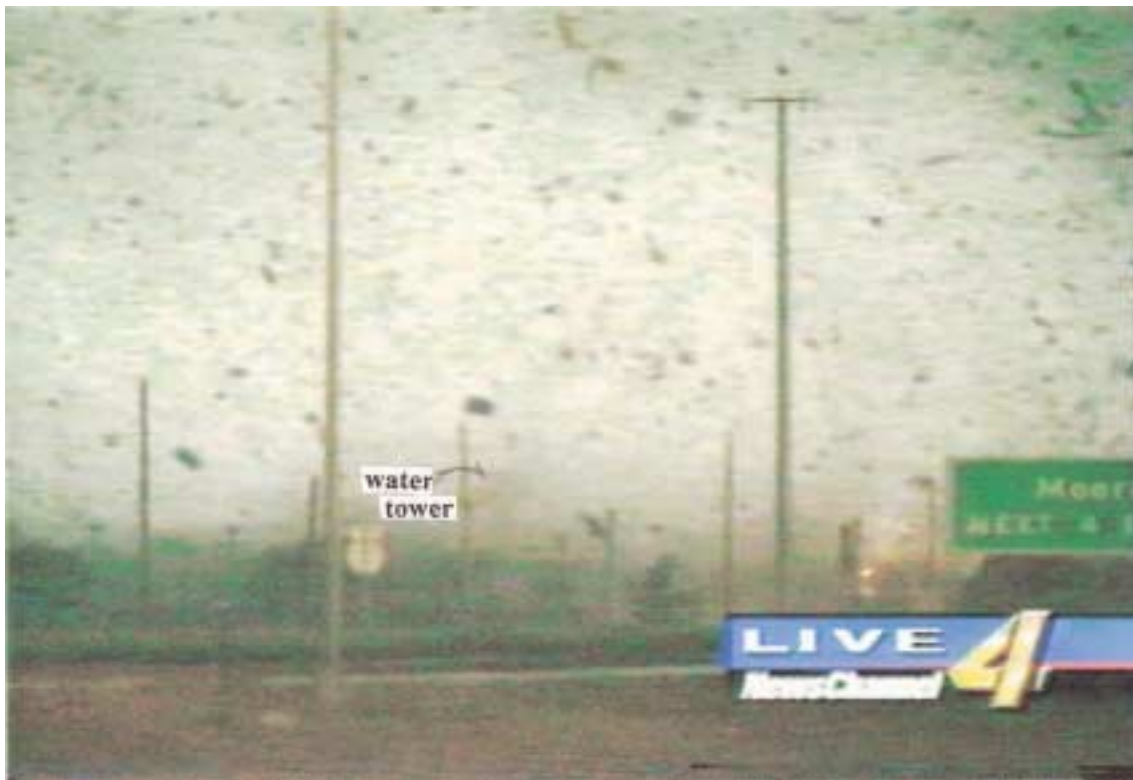
Photo. 4 Falling thick debris between Moore water tower and SE89th (from video by KFOR-TV)

After crossing I-35, the tornado attacked Highland District. Photo. 3 shows that a typical revolving flows with unstable wind direction damaged this area; cars were carried one block away. At this time, CH4's car reached the crossing of I-35 and SE89 Street (Fig.3), and videotaped the scene in the south. Photo. 4, taken from the videotape, shows the debris falling thick. Where was the debris sucked up into the air? Judging from the thickness of the debris, it seems that we can exclude distant places such as West Moore and the circumference of the main vortex's core. It seems natural that objects around Kelly Elementary School were torn off by small vortexes, flown into the circulating main vortex, carried from the east to the north, and fell between the water tower and

SE89th Street, which is far away from the course of the main vortex.

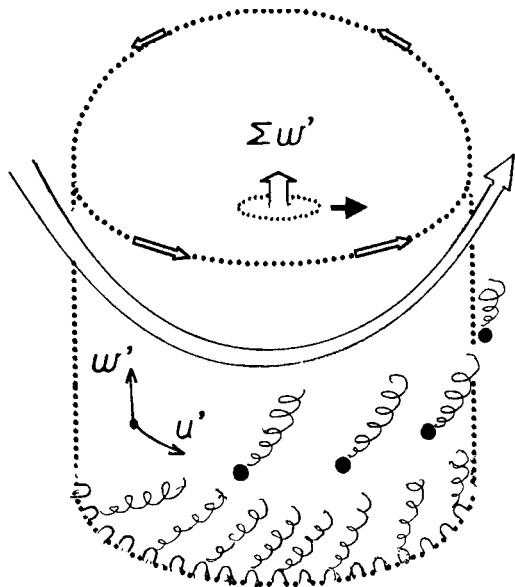
Fig. 4 Systematic flow pattern in right side of tornado-rotational stream

Although a detailed structure of the tornadic vortex standing still on the ground was investigated by Rotunno (1984), we placed focus on the ground surface friction of a counterclockwise rotating cylindrical air mass in which the full system of the vortexes was built. When the cylinder imitated by the parent vortex horizontally moves keeping its shape, the rotational axis deviates toward right side of the line the cylinder goes on, because the frictional stress becomes stronger at the right side and weaker at the left. Therefore, the flow is faster at the narrow right side of the axis, and slower at the wide left side. Let us consider a small vortex at the bottom of the side surface of cylinder, with its top slanted along the direction of cylinder rotation (Fig. 4). If the velocity increments induced by the child vortex with the same rotational component as the cylinder is u' in the rotational direction and w' in the upward direction, $u' > 0$, $w' < 0$ outside and $u' < 0$, $w' > 0$ inside the cylinder, and the Reynolds stress $\rho \overline{u'w'} < 0$ (ρ : air density) acts as the friction.

the roads. Therefore it is thought that small vortexes hardly caused the destruction and winds that blew almost straight were the main factor of the destruction. What matters here is whether a parent vortex causes downward wind without a hard child vortex. The uplifting flow at the parent vortex center in Fig.4 is also the driving power of the tornado rotating system on the ground. If the up-drift is slow, it is inferred that the parent vortex itself became too weak

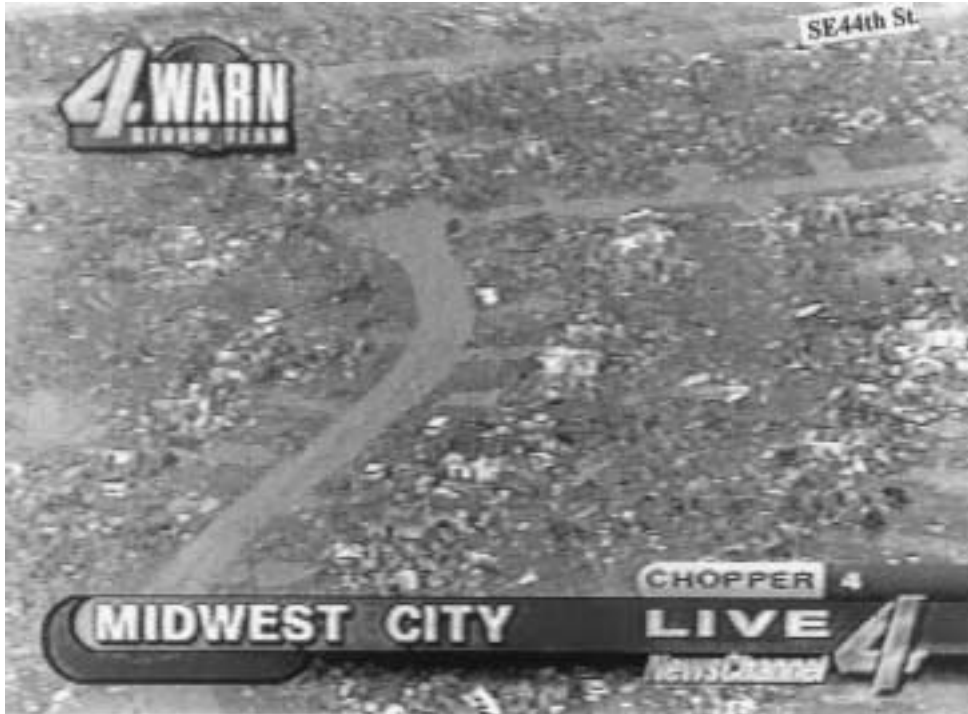
Photo.5 Disaster of Oakbrook Dr., tornado coming from top to bottom , compared with Photo.2 (from video KFOR-TV, not Midwest City but Del City)

As far as we look at the distribution map of damaged areas made by the computer team of Oklahoma City (The Sunday Oklahoman May 9 1999), there seems to be nothing strange about the damage. Since this shows only the final condition of the tornado, let us check in detail. First, in Del City, the tornado killed several people, and Oakbrook Drive, just north of SE44th Street, was the center of the damage. CH4's helicopter reported the destruction next day (Photo.5). Seeing carefully, we notice a slight difference from Eastlake (Photo.2). The tornado completely destroyed homes 100 yards wide in both areas, but in Del City there remained many projecting things and little debris could be seen on

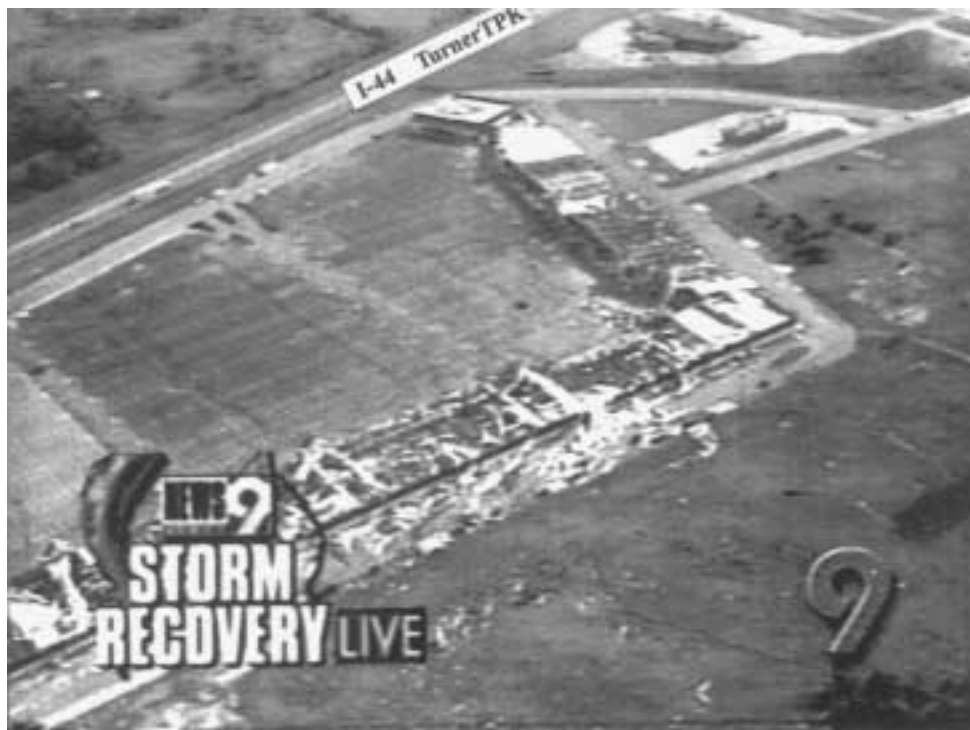
Photo. 7 Disaster of Tanger Outlet Mall in Stroud (from broadcast by KWTV)

hospital, a storehouse and some homes were destroyed, the most damaged was Tanger Outlet Mall. This shopping mall occupies 200,000ft² at the north of the west exit of I-44, which runs east to west along the north side of the town. In that vast lot the one-storied market that is one mile long is placed like the letter U (Photo.7), its open side facing I-44 and the center space being the parking area. The downburst brushed by the road from the southwest and blew out the west wing to the parking lot and the other part of building outward, their exterior and interior together. A glimpse of the destruction was enough to convince us that it resulted from a different type of downdraft from that of Midwest City, which was gradually ending. We have ever seen the same type as this in the suburb near Little Rock Airport in 1997 (Photo. 8). But we do not have a definite explanation of where the falling cool air perhaps with momentum of a jet stream comes from. The nearest tornadoes were in Shawnee or Meeker, but we cannot exclude the
